Notices to Mariners, SWEDEN Swedish Maritime Administration

Areas in Swedish Notices to Mariners

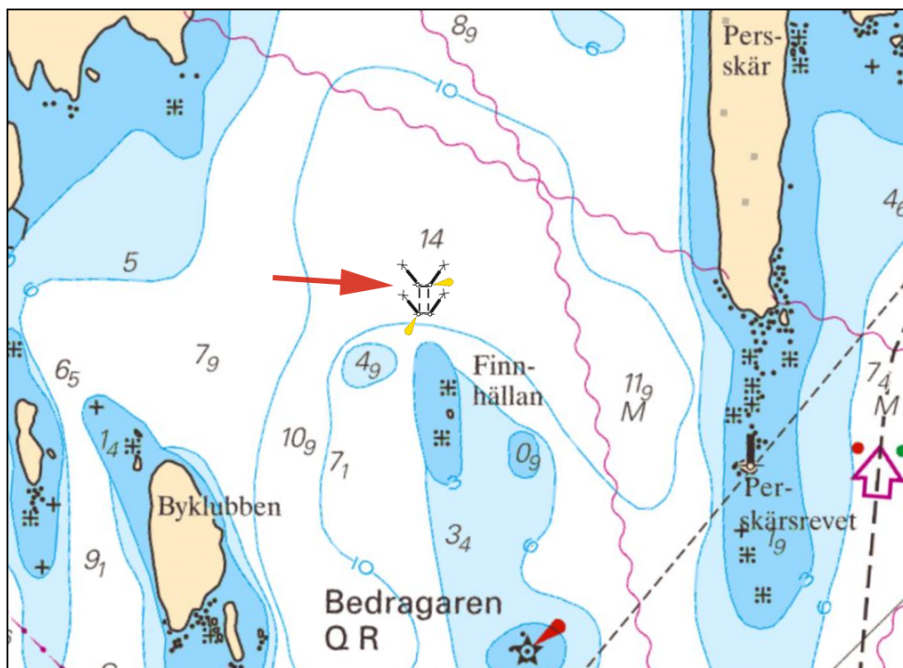
NW of Norrbyskär

Sweden. Sea of Bothnia. NW of Norrbyskär. N of Finnhällorna. Test of environmental research equipment. Buoyage.

Insert	Restricted area inside a) - d)			
Insert	yellow special spar buoy	a)	63-33,816N	019-50,907E
Insert	yellow special spar light buoy, Fl Y 3s	b)	63-33,816N	019-50,920E
Insert	yellow special spar buoy	c)	63-33,787N	019-50,920E
Insert	yellow special spar light buoy, Fl Y 3s	d)	63-33,787N	019-50,907E

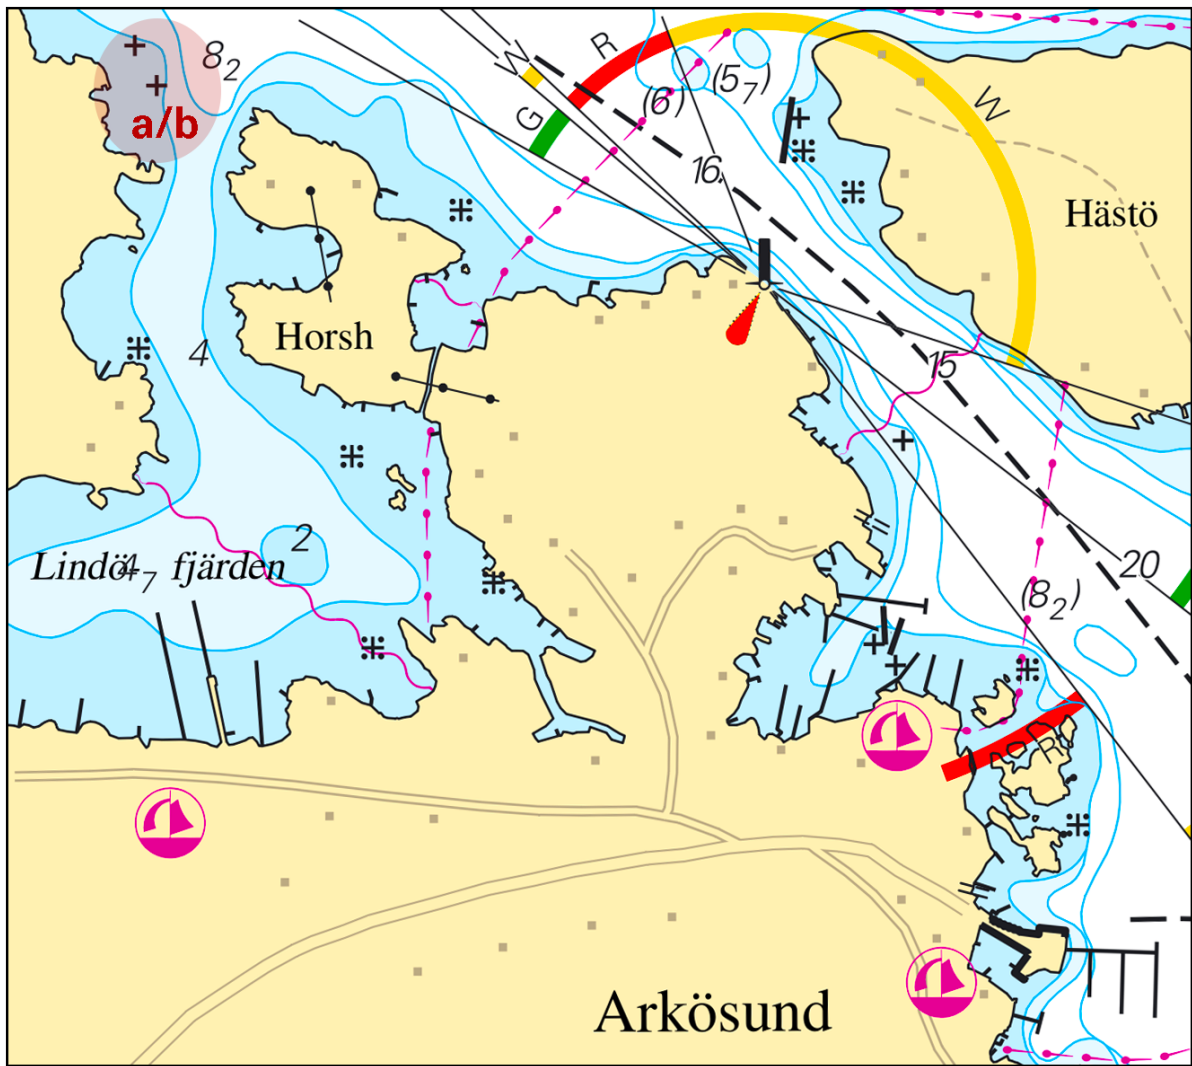
Arkösund

Sweden. Northern Baltic. Arkösund. Lindöfjärden. Snedskär. Piers. Shore line contours. Underwater rocks.

Insert	underwater rocks in a) and b)	a)	58-29,959N	016-55,347E
		b)	58-29,936N	016-55,538E
Amend	depth contours and shore line as shown in chartlet

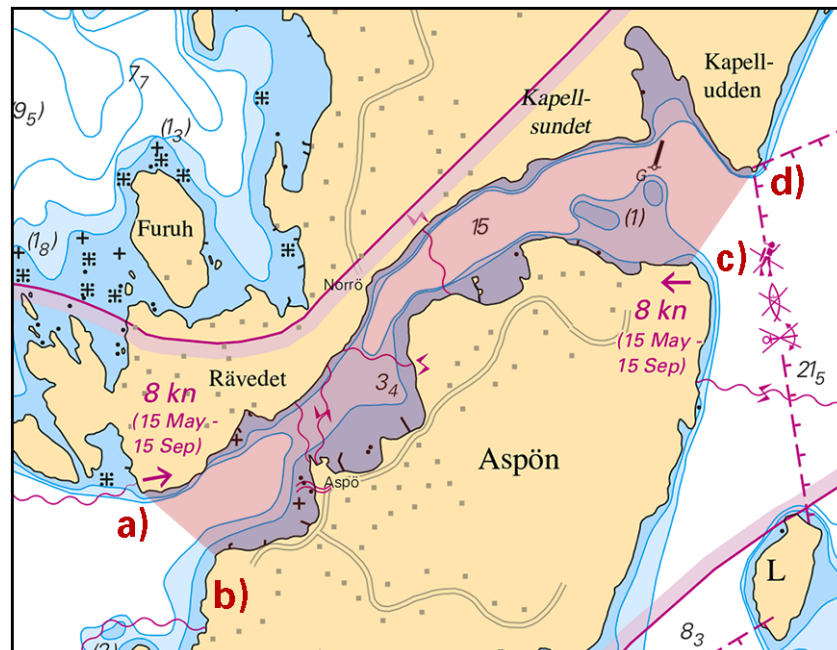
Seasonal speed limit in Kapellsundet

A speed limit of 8 knots applies for all vessels inside the highlighted area as shown on the chartlet.

Insert	texts '8 kn' and '(15 May - 15 Sep)' as shown			
	speed limit area limited by points a) - b) and c) - d) respectively	a)	58-54,05N	018-08,45E
		b)	58-53,98N	018-08,62E
		c)	58-54,33N	018-09,73E
		d)	58-54,45N	018-09,89E

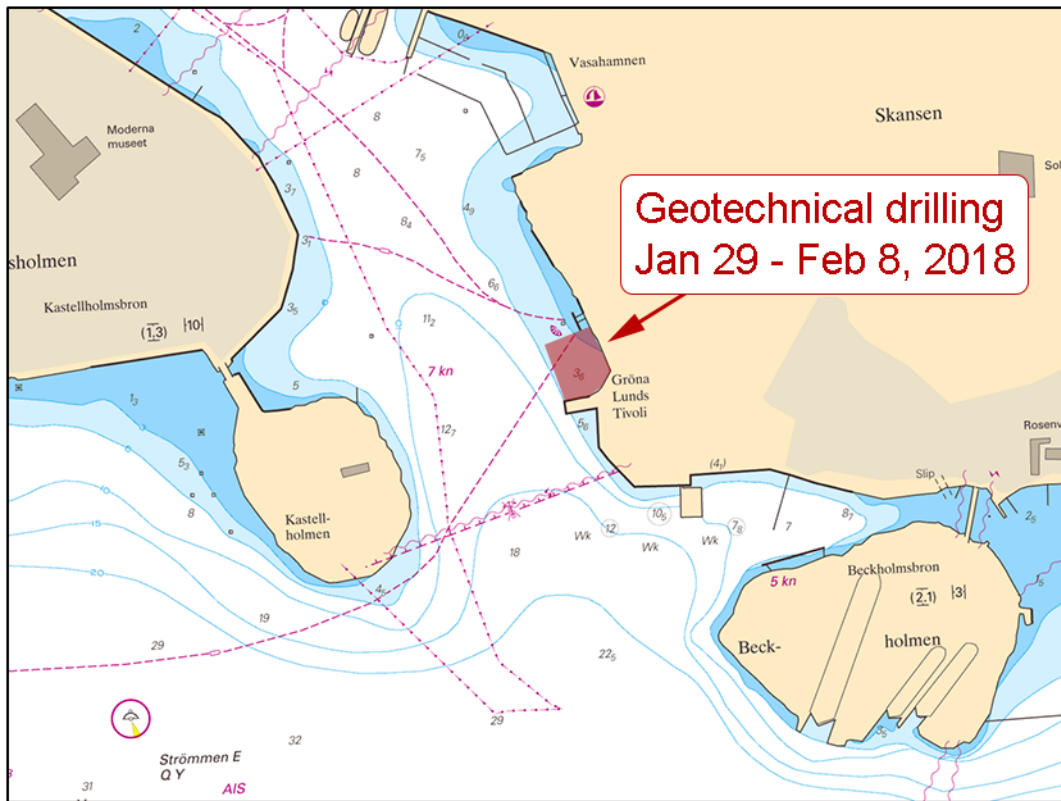
Work area, Gröna lund

Geotechnical drilling in progress at Gröna Lund in Stockholm.

Vessels in the area are requested to pass with reduced speed.

Work area at Gröna Lund	59-19,42N	018-05,66E
-------------------------	-----------	------------

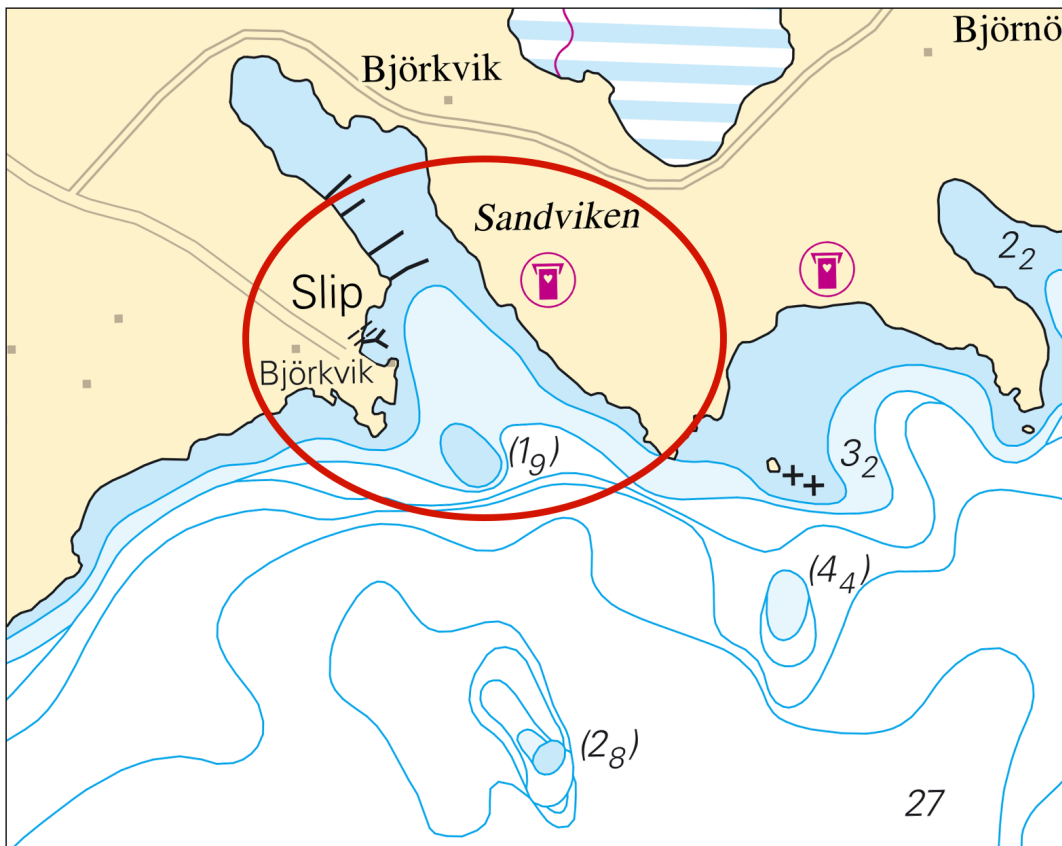
Amended depth contours, Björkvik

Sweden. Northern Baltic. Stockholm archipelago. Ingarö. Björkvik. Less depth.

Amend	3- and 6 metre depth contour according to chartlet	59-13,2N	018-32,5E
-------	--	----------	-----------

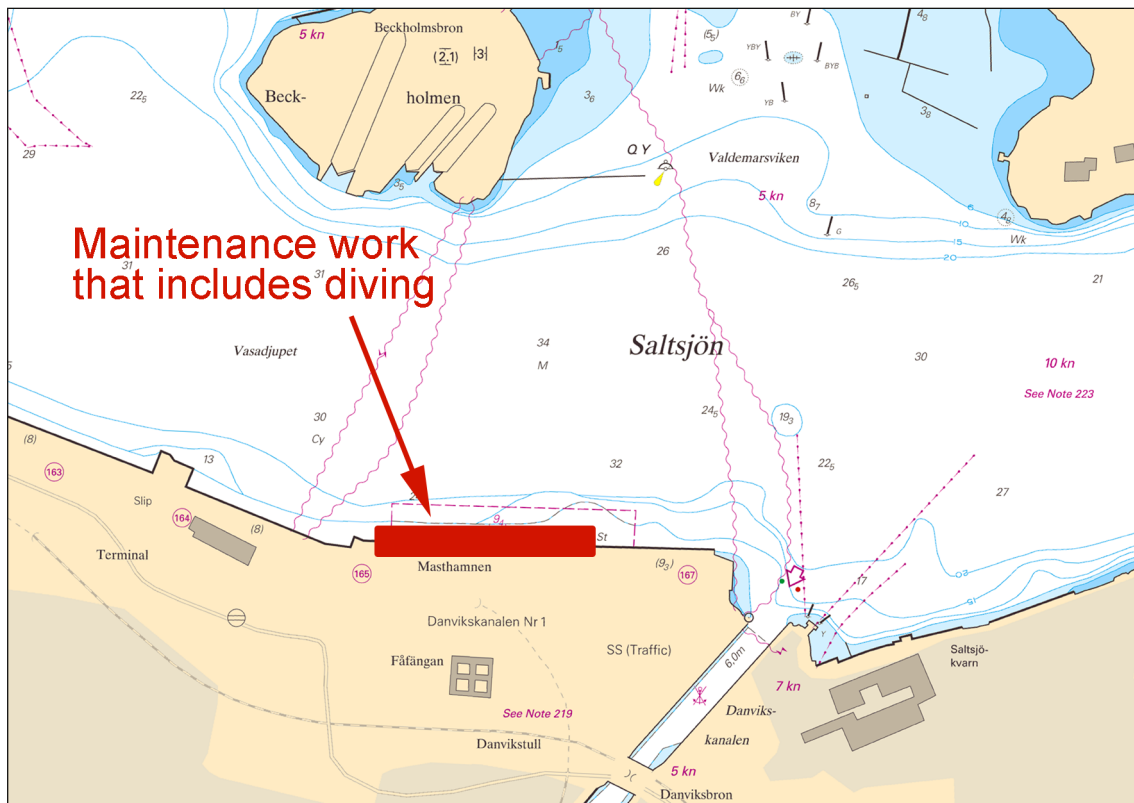
Maintenance work, Masthamnen

Maintenance work in progress along the quay at Masthamnen in Stockholm, berth 165 - 167. The work includes diving operations.

Work area, Masthamnen in Stockholm	59-18,97N	018-06,10E
------------------------------------	-----------	------------

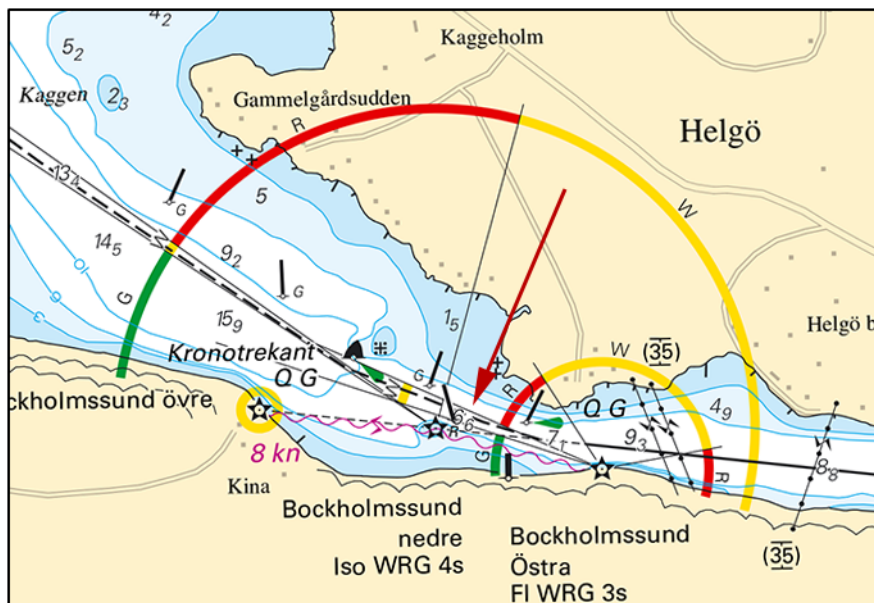
Bockholmssund

Sweden. Lake Mälaren and Södertälje kanal. Mälaren. S of Helgö. Bockholmssund. Depth.

Delete	depth 6,9 m	59-16,44N	017-39,95E
Insert	depth 6,6 m	59-16,44N	017-39,90E

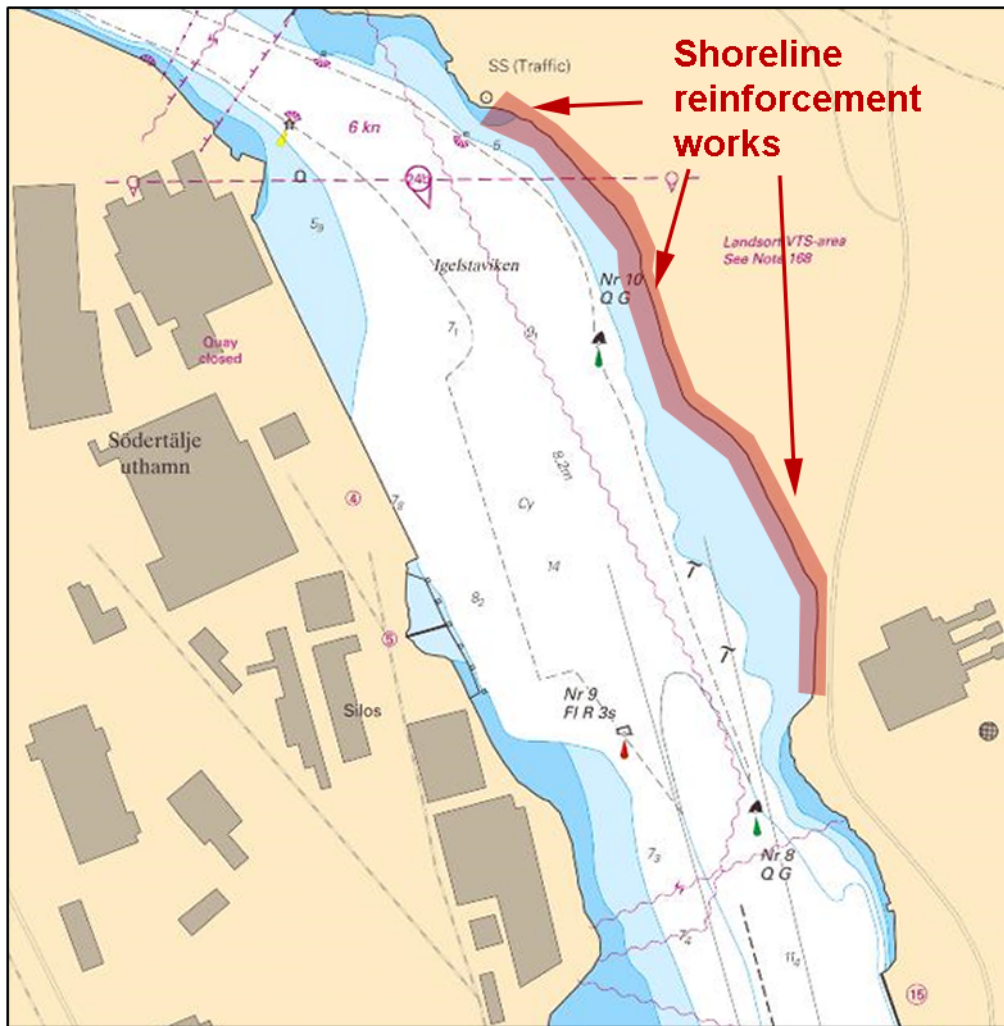
Reinforcements, Igelstaviken south of Södertälje

Igelstaviken	59-10,81N	017-39,63E
--------------	-----------	------------

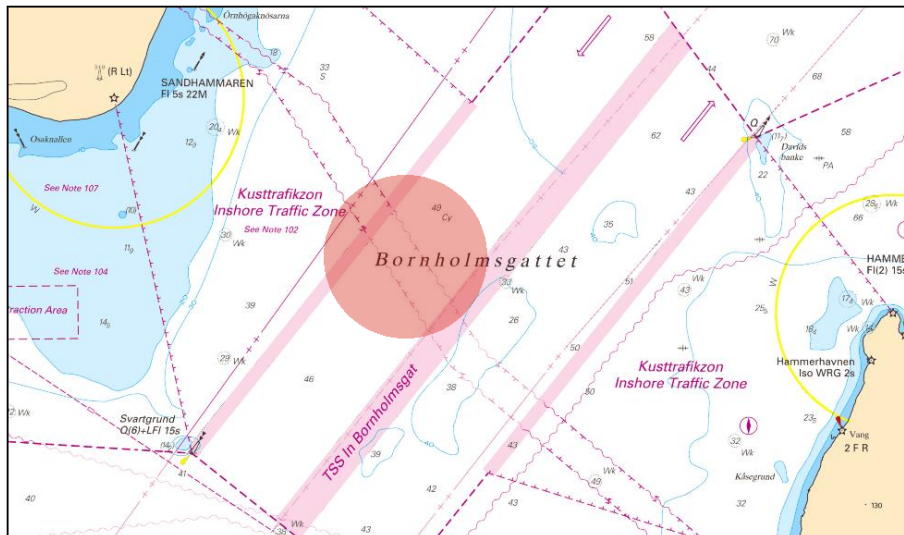
Cable works in January 2018

Cable repair in progress within 2 M radius from stated position. Divers and ROV are used.

Centre of working area, radius 2 M		55-19,2N	014-24,7E
PARTICIPATING VESSELS			
Havila Subsea/LGSY3	Offshore supply ship, 98 x 20m. Tel: +4790757746.		
Cable One/OVZC	Cable layer, 39 x 10m. Tel: +4540345311, +4532712684		
Venus II/HP9337	Guard ship, 31 x 7m

Ships are recommended to call any of the participating vessels on VHF Ch 16 to obtain advise for safe passage of the working area. The participating vessels could also be contacted on telephone as below.

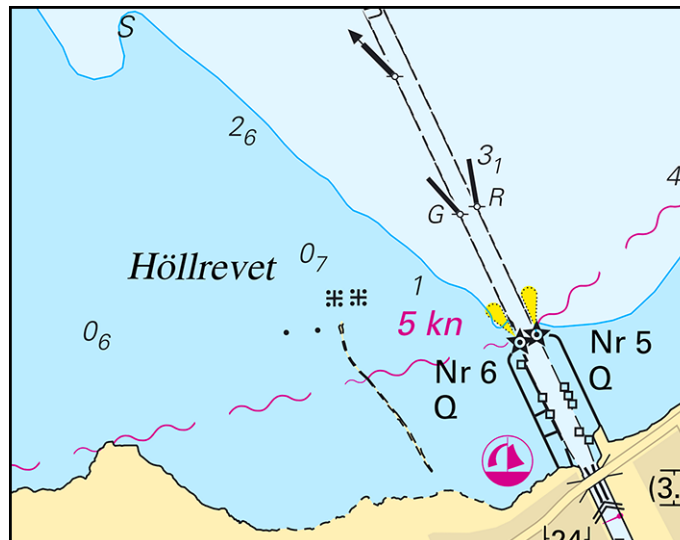
Restricted area withdrawn at Höllviken

Delete	restricted area at Höllrevet	55-24,91N	012-55,07E
--------	------------------------------	-----------	------------

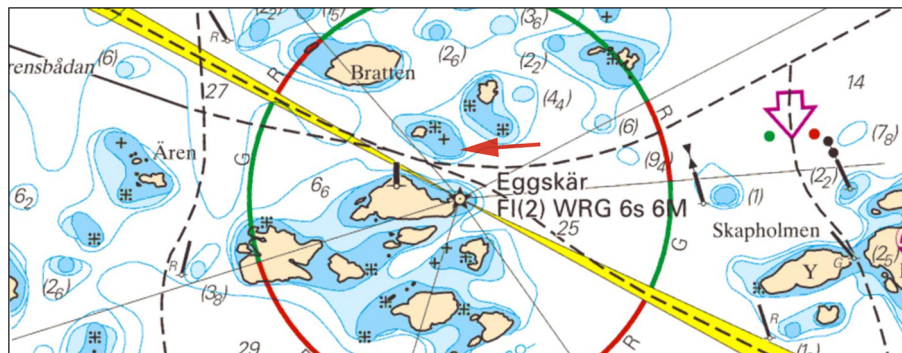
Shoal N of Eggskär extended eastwards

Sweden. Skagerrak. V of Tjörn. N of Eggskär. Shoal extended.

Amend	3 and 6 m contour E to include	57-56,845N	011-31,018E
-------	--------------------------------	------------	-------------

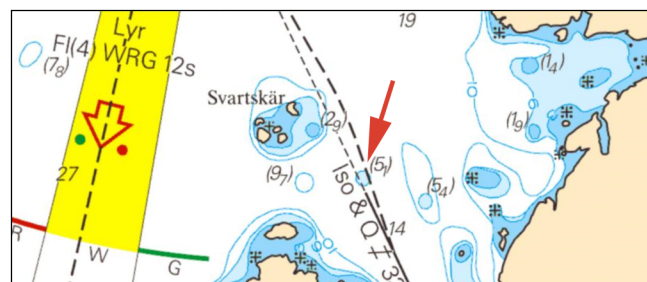
Shoal N of Skaboholmen

Sweden. Skagerrak. V of Tjörn. N of Skaboholmen. Shoal.

Insert	5,1 m with associated 6 m contour	58-02,592N	011-29,834E
--------	-----------------------------------	------------	-------------

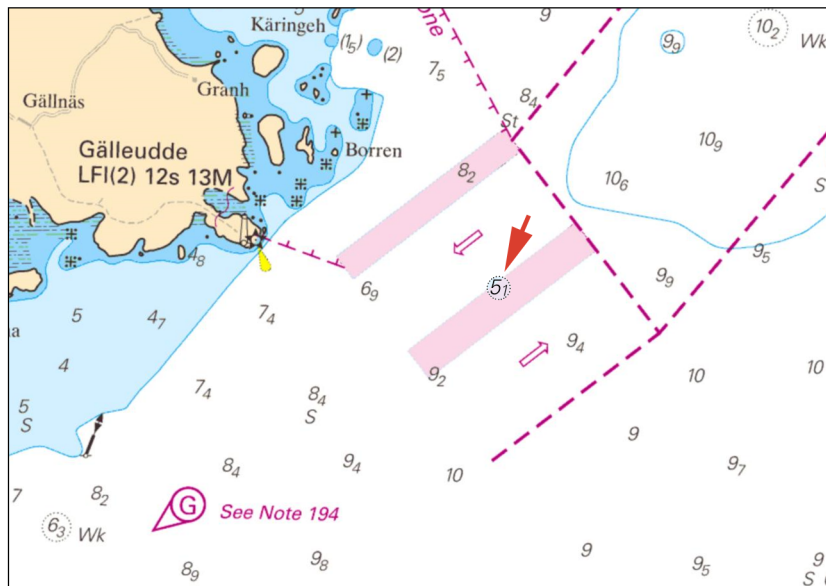
Sweden. Lake Vänern and Trollhätte kanal. Vänersborgsviken. E of Gälleudde. Obstruction in the separation zone.

Insert	obstruction, 5,1 m	58-28,989N	012-29,889E
--------	--------------------	------------	-------------

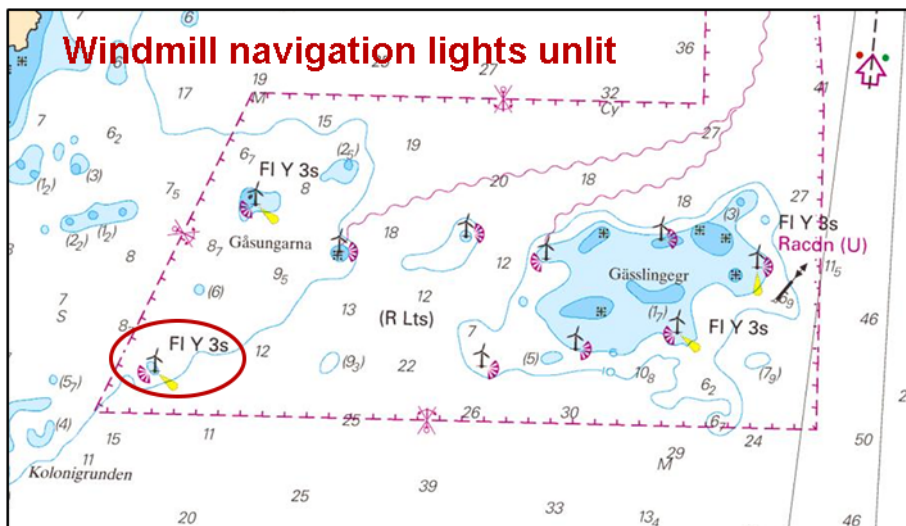
Windmill unlit S of Skoghall in Lake Vänern

Unlit windmill	59-15,44N	013-20,90E
----------------	-----------	------------

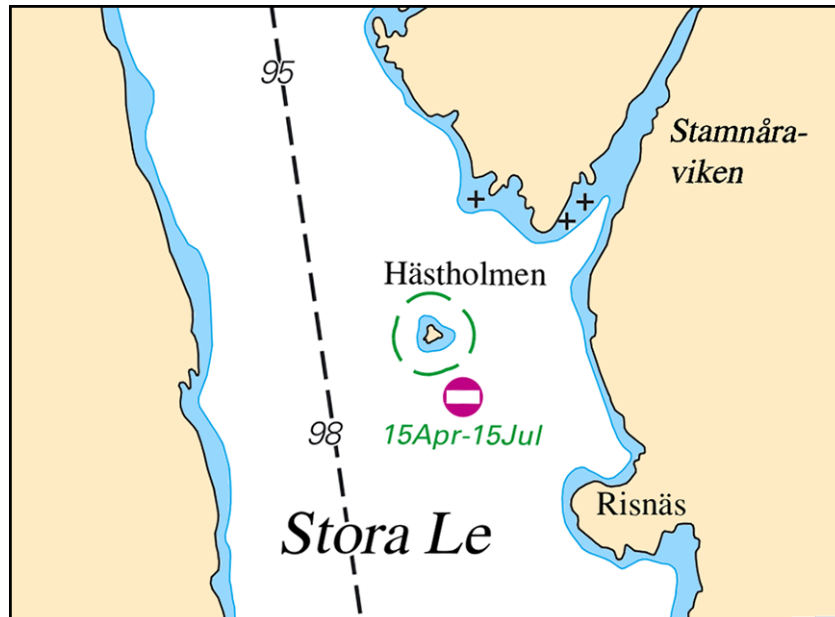
Hästholmen, Lake Stora Le

Sweden. Inshore waters. Dalsland Canal. Lake 'Stora Le'. Hästhölm. Nature reserve. Entry prohibited annually April 15 thru July 15.

Amend	island 'Hästholmen' as shown and move it 85 metres northward to	58-59,340N	011-54,560E
Insert	nature reserve with adjoining text and markings as shown on chartlet
